# Screw-Retained Single Implant Restorations

## Part I

By Robert Winter (/spear-review/author/bob-winter/) on February 28, 2018 | (/bookmarks/bookmark/39275)

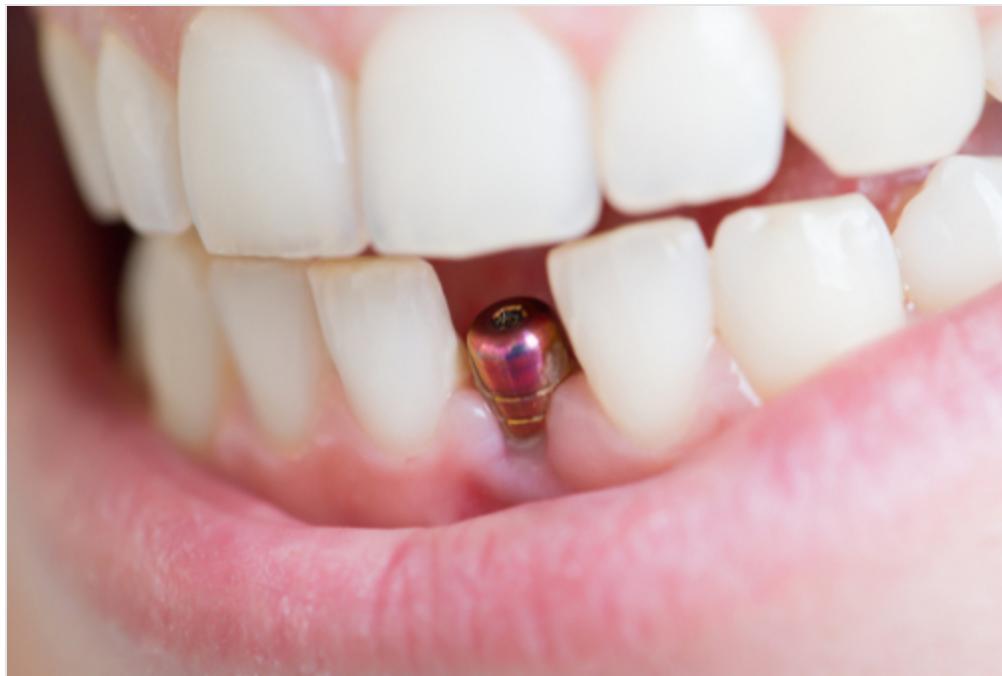
Typically, screw-retained restorations are fabricated as one piece; the abutment and crown are contiguous. The connection to the implant can be metal (as in a metal ceramic restoration) or a TiBase.

The TiBase is connected to the restoration by bonding with a resin cement, or has frictional retention to the zirconia (<https://online.speareducation.com/course/adjusting-and-polishing-zirconia-restorations>) or e.max restoration. It is possible to have an all-zirconia restoration with the connection to the implant also being zirconia. This may be the least advantageous due to the increased risk of the zirconia connection fracturing, and the zirconia will wear the titanium implant due to micromovement.
